SUBJECT: GRIFFITH PARK – LA SHARES BUILDING DEMOLITION (PRJ21500) PROJECT – COMMITMENT OF PARK FEES – STATUTORY EXEMPTION FROM THE PROVISIONS OF THE CALIFORNIA ENVIRONMENTAL QUALITY ACT (CEQA) PURSUANT TO PUBLIC RESOURCES CODE SECTION 21080(b)(4) AS A SPECIFIC ACTION NECESSARY TO PREVENT OR MITIGATE AN EMERGENCY

# Technical Memorandum

**Project:** LA SHARE Building

**Subject:** Structural And Fire Assessment

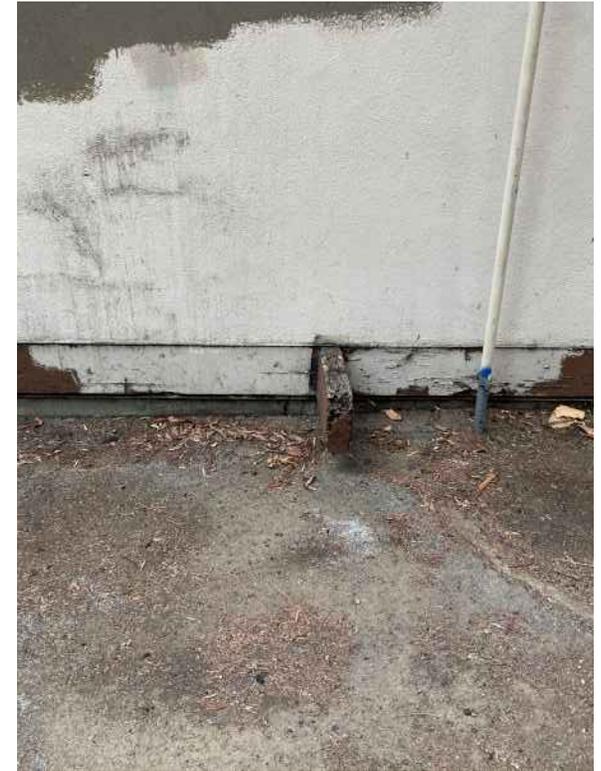
**Photo 3: Rotting Wood Beam of Raised Floor On Western Portion of Building**

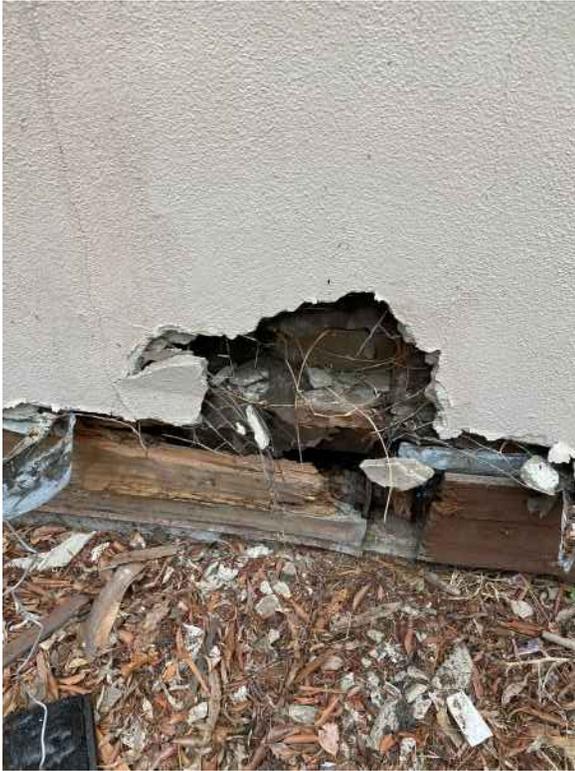
**Photo 4: Existing Hole at Bottom of Building.**

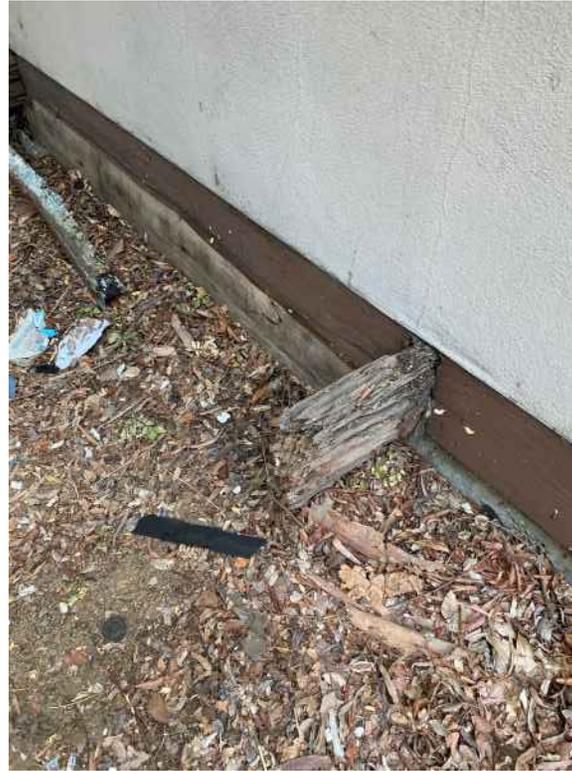
**Photo 5: Rotting Wood Beams for Raise Floor**

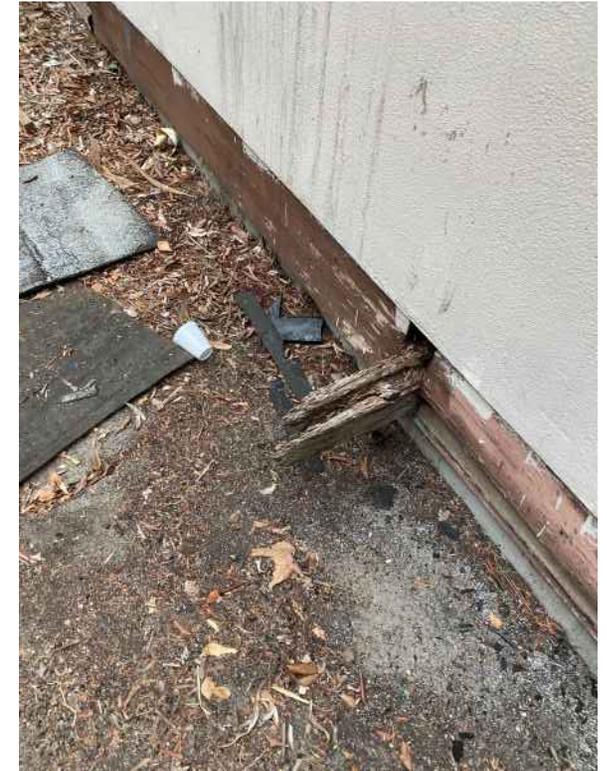
**Photo 6: Rotting Wood Beams for Raise Floor**

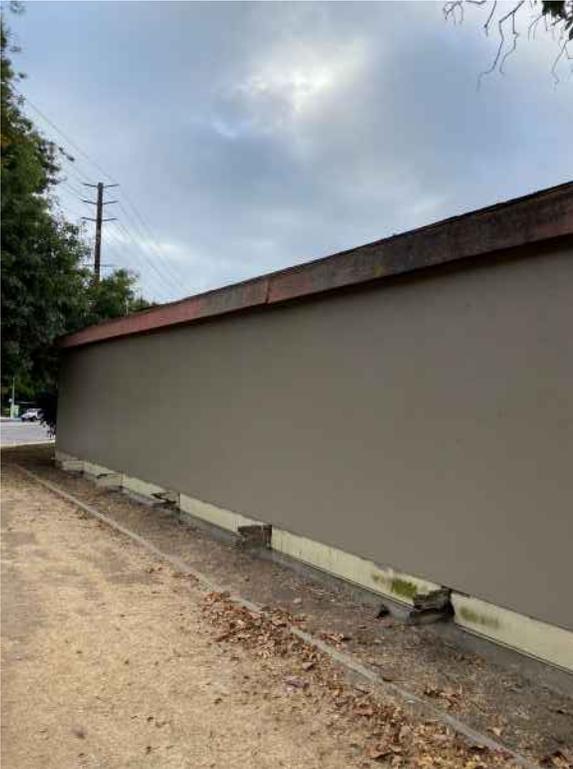
**Photo 7: Exterior Eastern Portion of Building w/ Burned Rooftop**

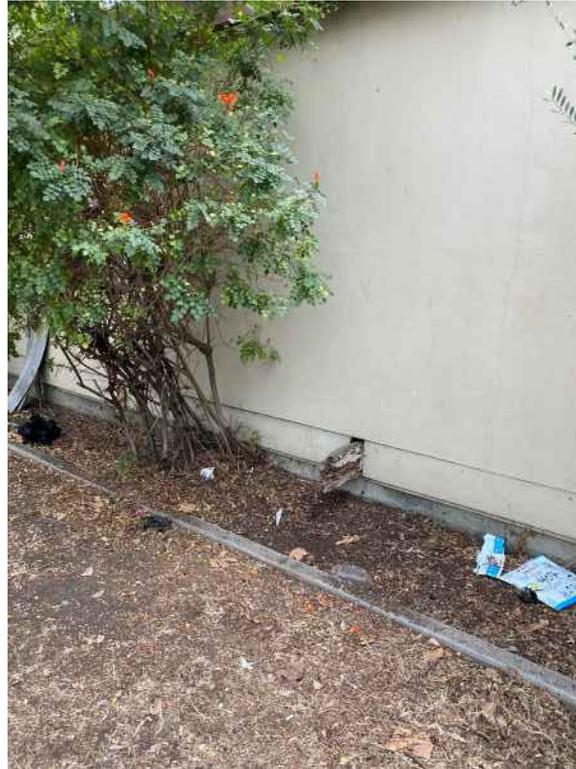
**Photo 8: Rotting Wood Beam of Raised Floor On Western Portion of Building**

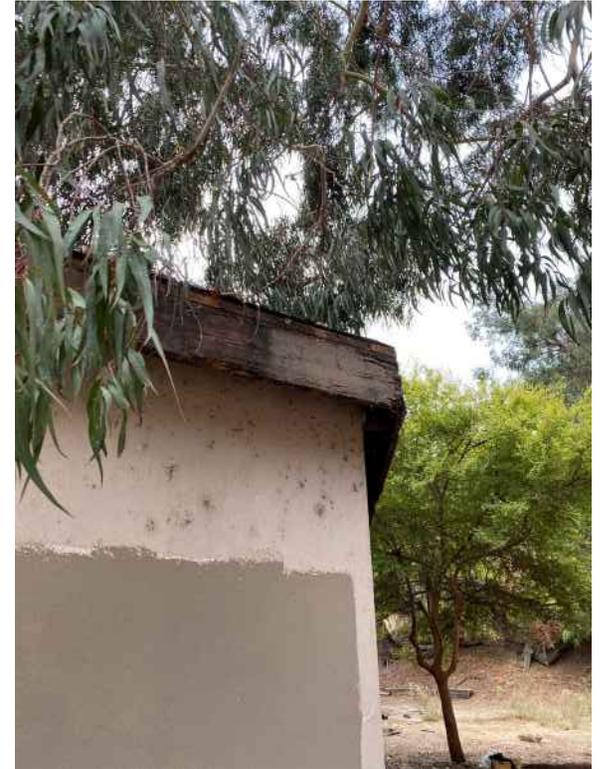
**Photo 9: Burned Rooftop**

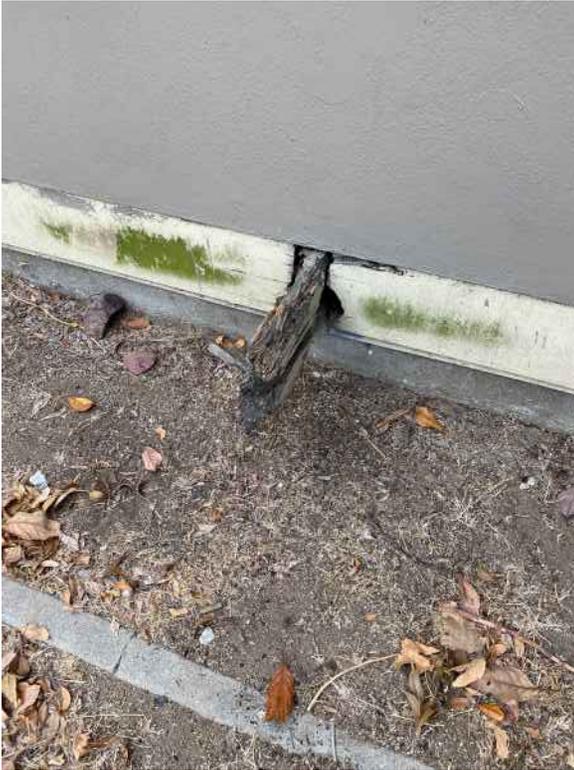
**Photo 10: Rotten Wood Beam for Raised Floor**

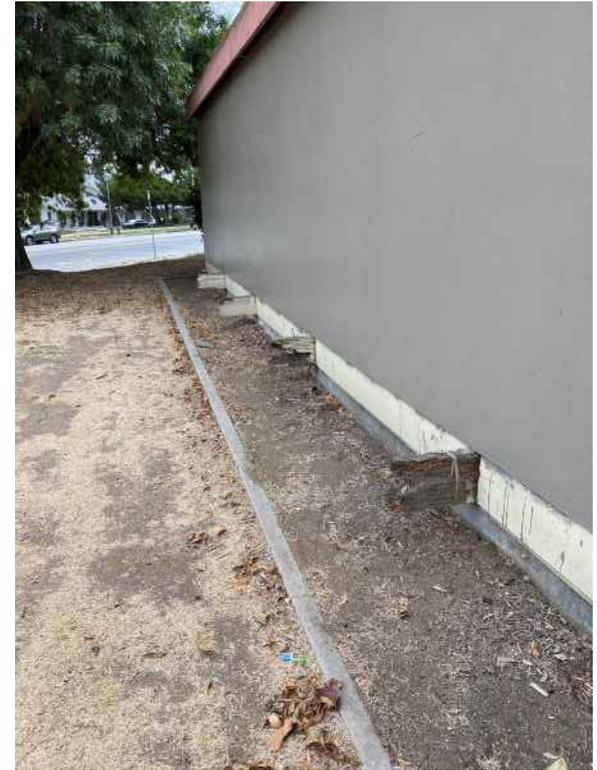
- After examining the walls, Tetra Tech found that the exterior rooms have a raised wooden floor supported by wooden beams which extend outside of the building (See Photo 12). These raised floors appeared to be elevated 1-foot maximum above the existing concrete surface (See Photo 16). As-built drawings were not available; therefore, the true elevation of the raised floor from the concrete surface is unknown. The floor material was determined using a tapping technique with a hammer. Tapping on a concrete slab will make a quick and dull sound while a wood platform will make a hollow sound. Tetra Tech could not fully assess the conditions of the wood floor due to the debris covering the floor and safety hazards. However, a structural assessment was performed of the raised floor support beams extending outside of the building. By observation, these beams show evidence of termite damage and dry rot due to years of outside exposure. During the examination, some of the beams were completely rotted away (See Photos 13 and 14). If further termite damage and dry rot occurs, the beams will continue to lose load bearing capacity and possibly cause floor collapse. Due to access limitations, Tetra Tech does not know if fire damage occurred under the raised floor. However, like the wood roof, the raised floor was exposed with no additional fire protections. Therefore, it is likely the raised floor and its supports are structurally compromised and must be demolished due a lack of structural integrity.

**Photo 12: Exterior Eastern Portion of Building w/ Rotten Wooden Beams**

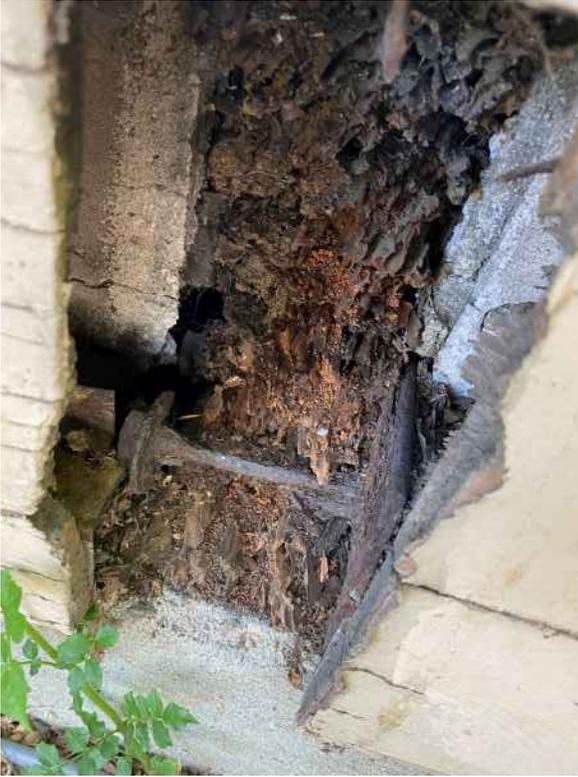
**Photo 13: Rotten Wood Beam**

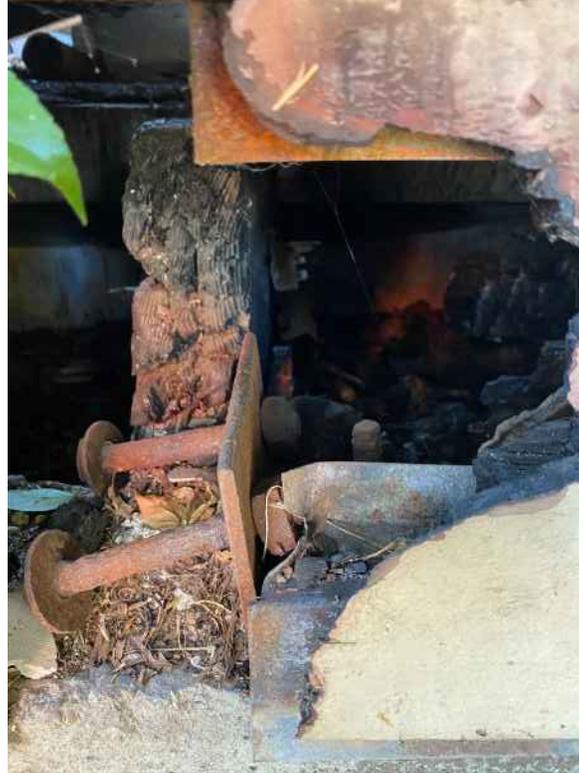
**Photo 14: Burned Wood Joist for Raised Floor**

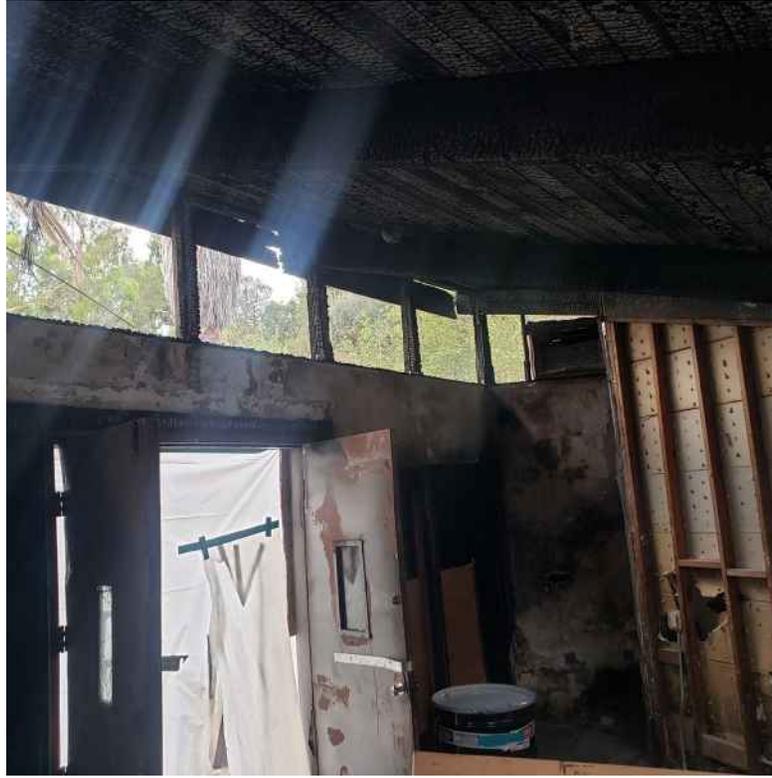
**Photo 17: Burned Rooftop and Framing**

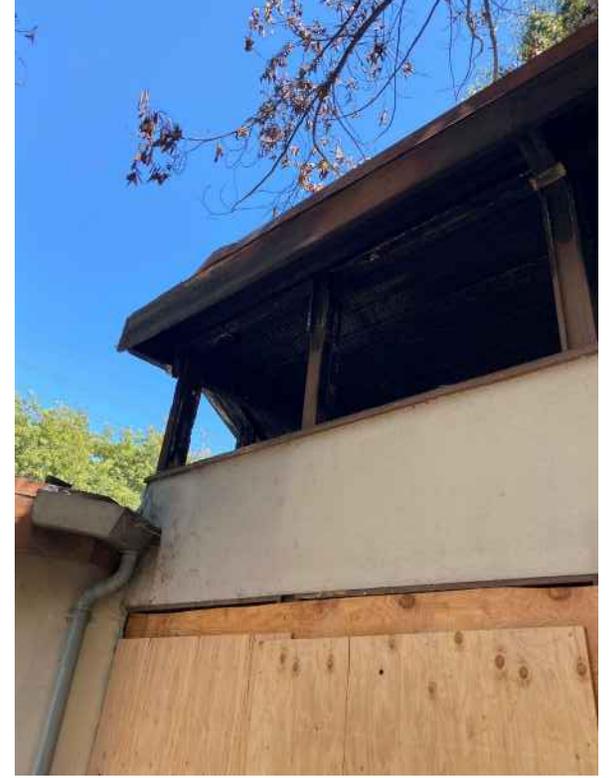
**Photo 18: Burned Posts in Rooftop**

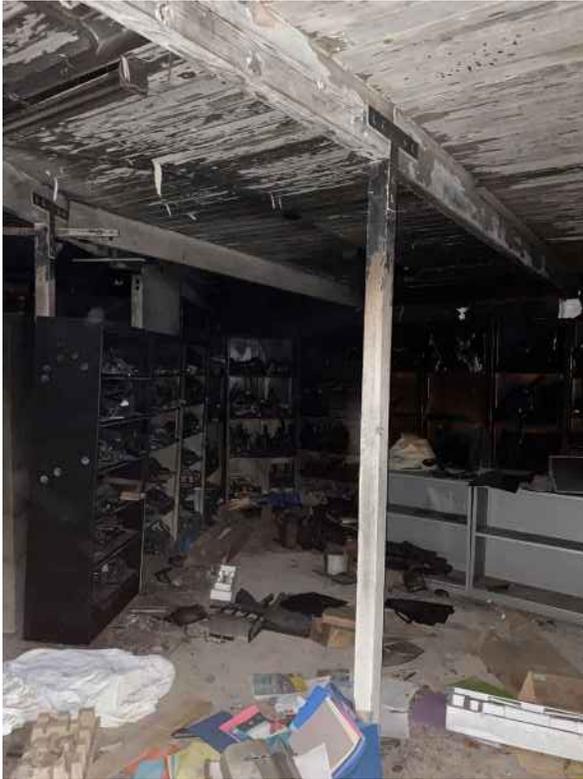
Photo 19: Smoked-Scarred Room

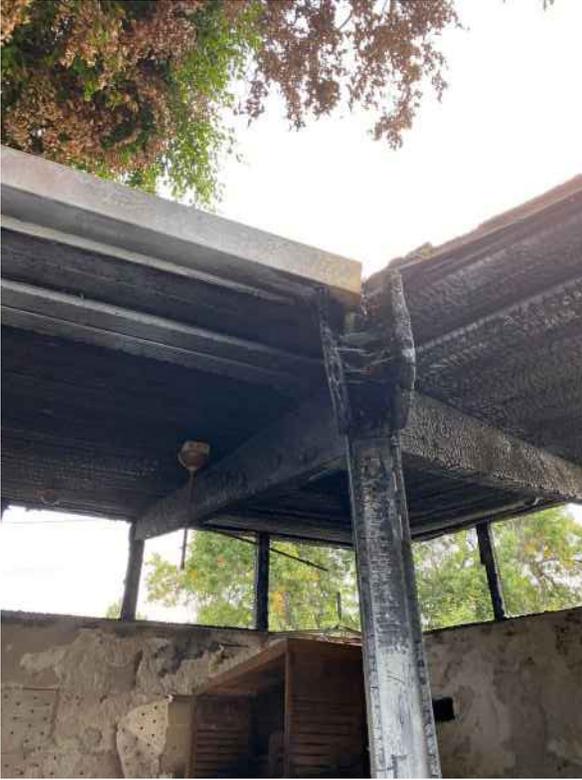
**Photo 22: Burned Roof and Beams**

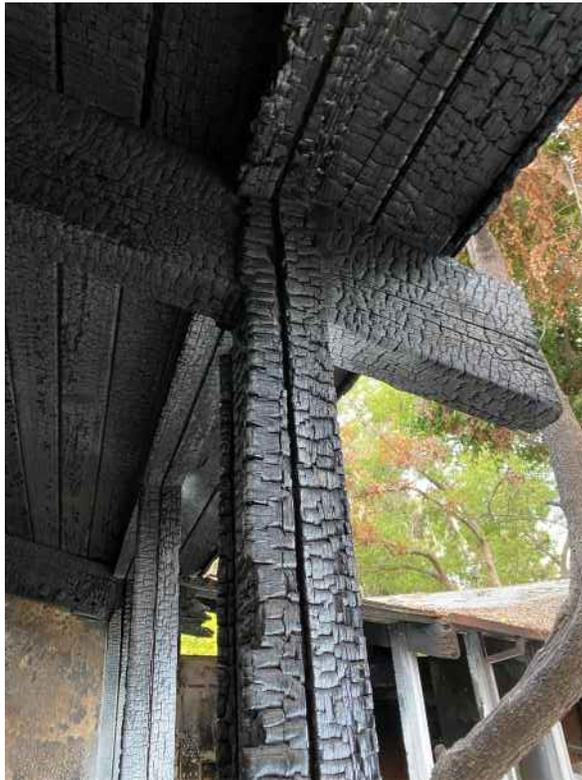
**Photo 23: Burned Interior Column**

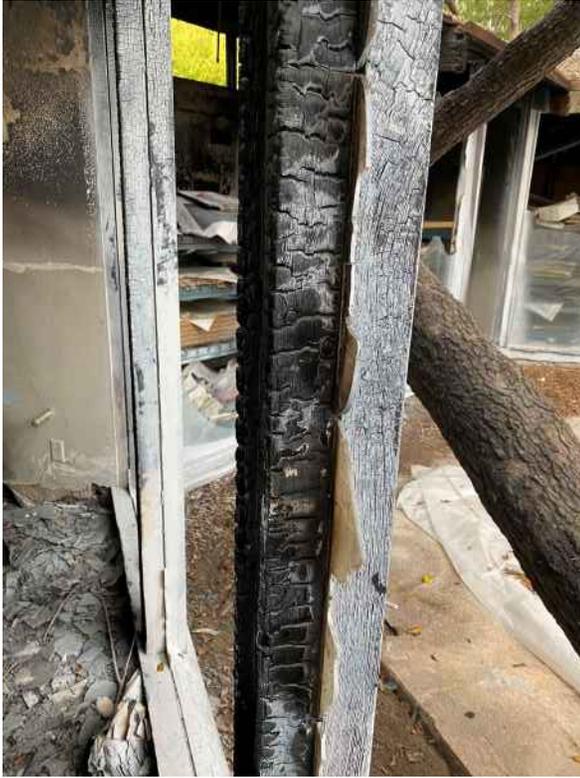
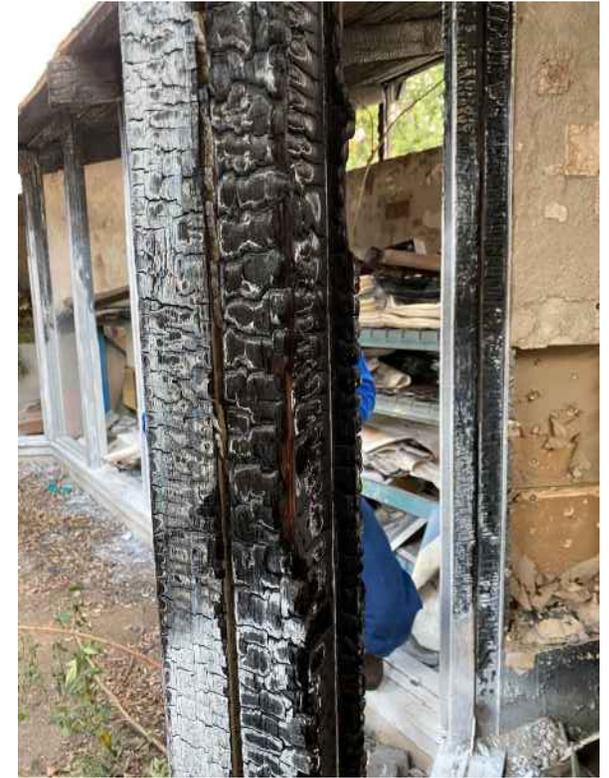
**Photo 25: Burned Interior Columns at Western Side**

**Photo 27: Burned Interior Columns at Western Side**

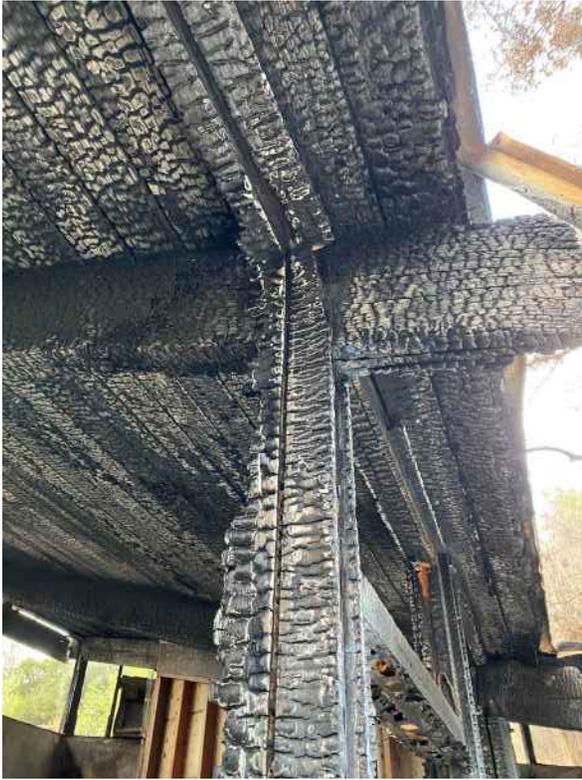
**Photo 28: Interior Column and Beam  
w/ Size Reduction**

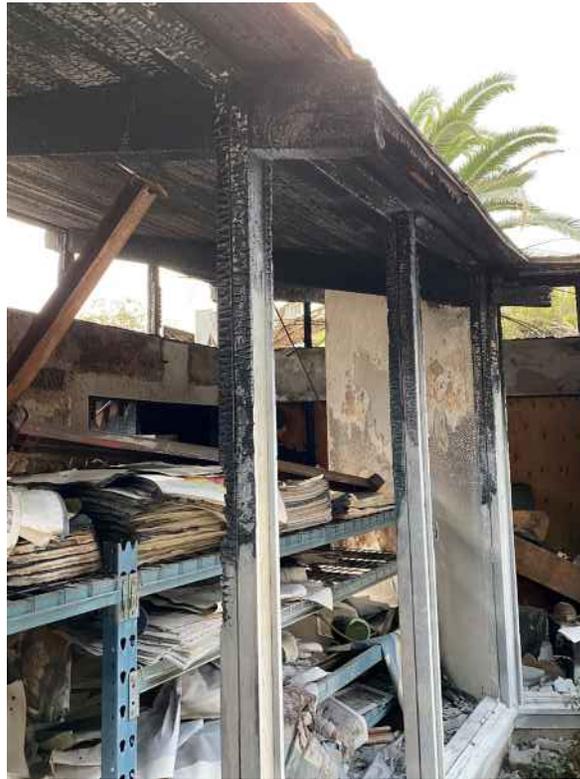
**Photo 29: Burned Beams at Building  
Center**

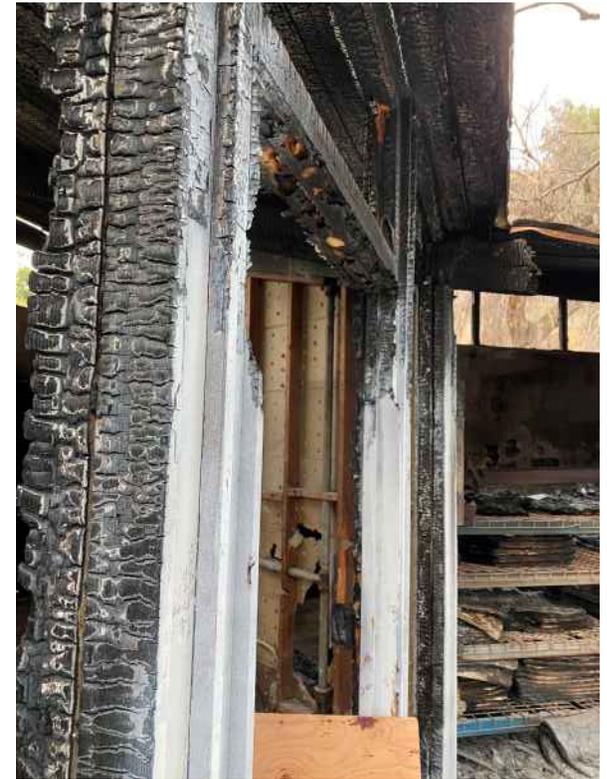
**Photo 30: Burned Interior Columns at  
Building Center**

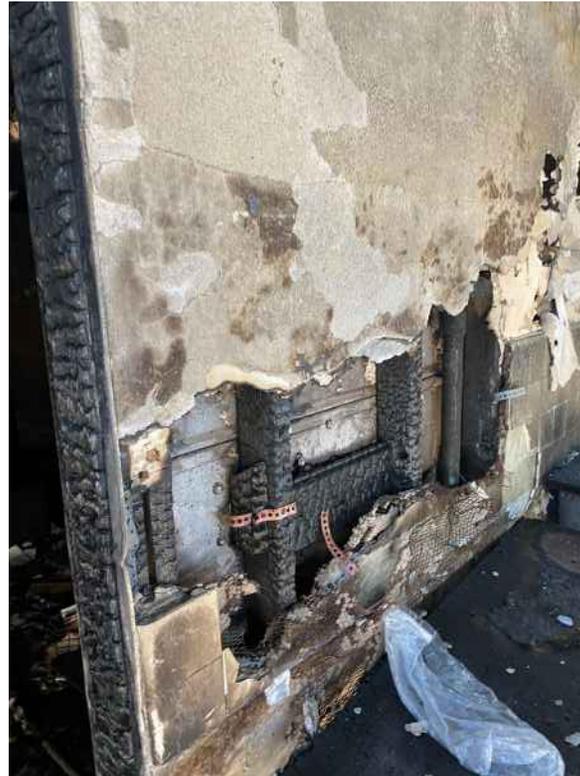
**Photo 32: Damaged Portion of Bearing / Shear Wall**

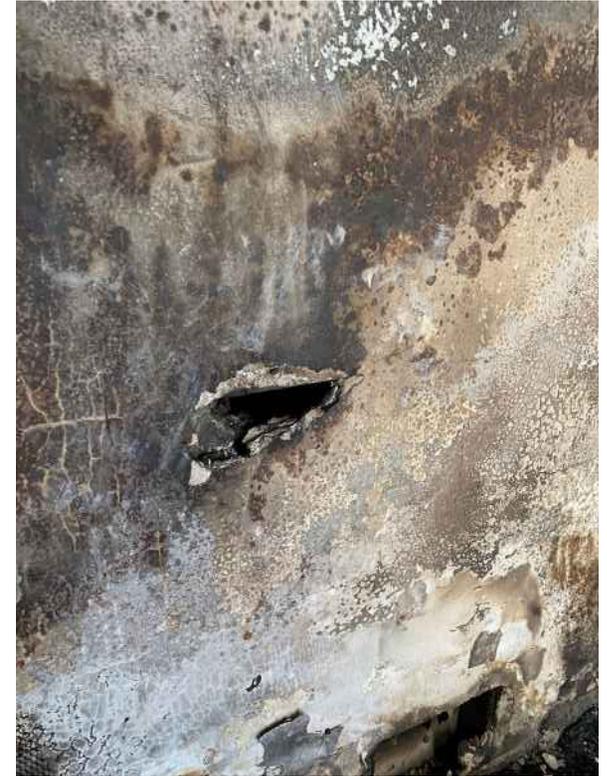
**Photo 33: Burned Gypsum Board on Wall**

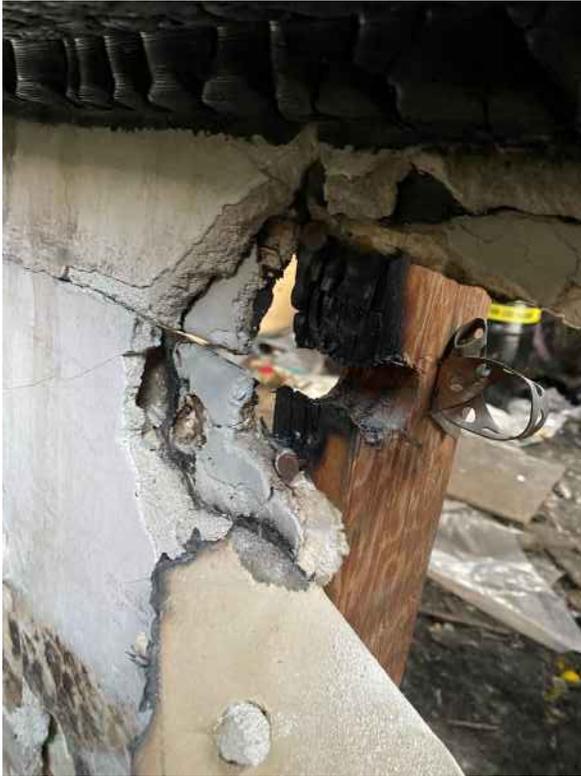
**Photo 34: Burned Post of Shear Wall**

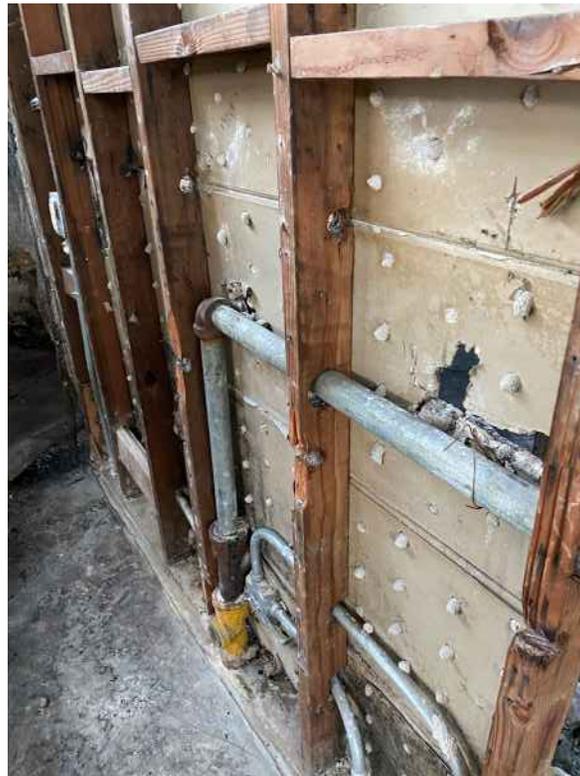
**Photo 35: Exposed Portion of Wall w/  
Termite Damage**

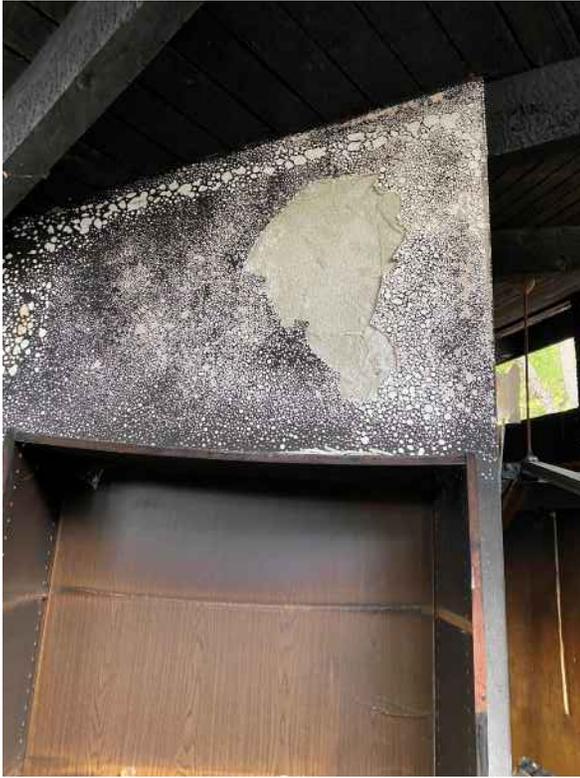
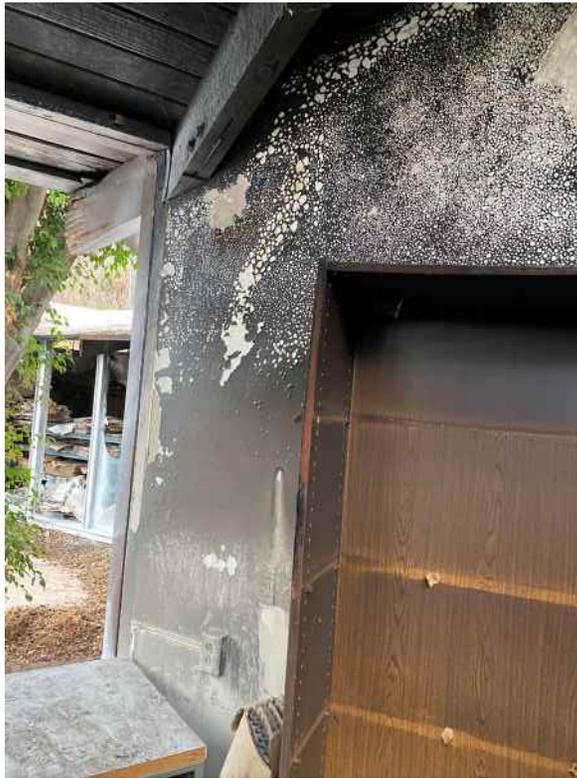
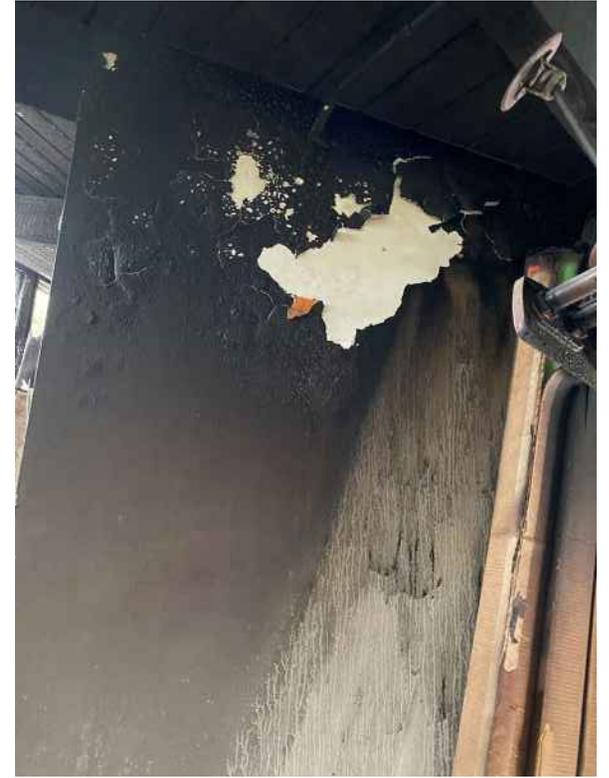
**Photo 40: Coating Spalling due to Fire**

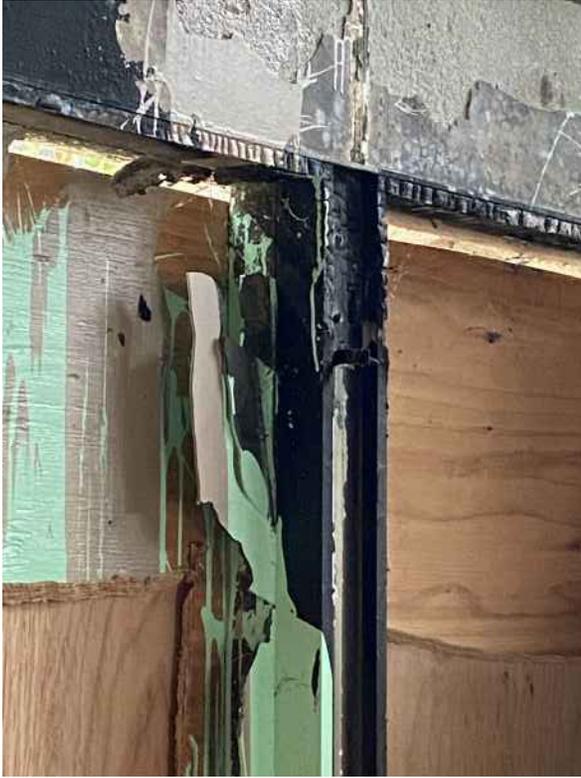
**Photo 43: Cracked Interior Column due to Fire**

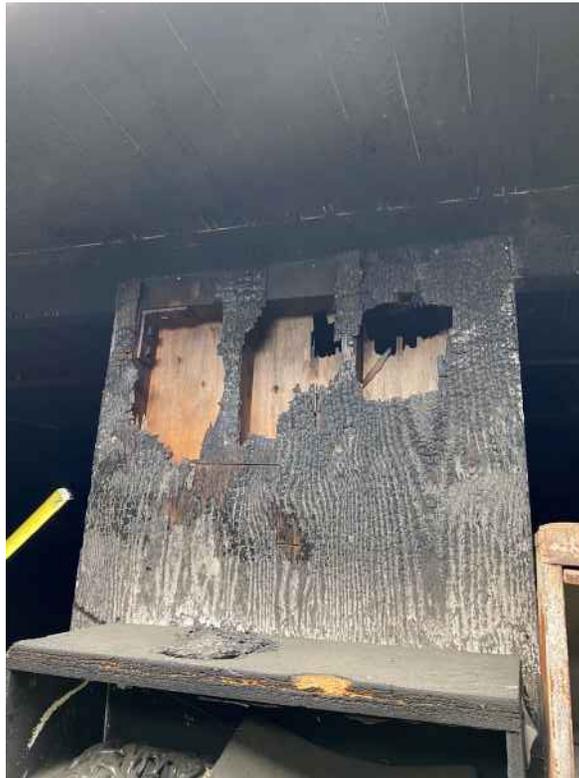
**Photo 44: Heavily Burned Interior Support Wall**

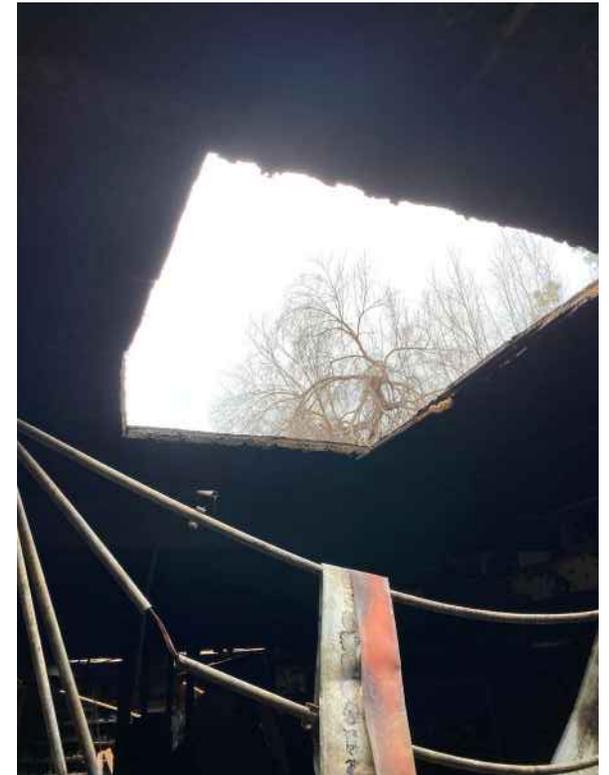
**Photo 45: Roof Opening due to Collapse**

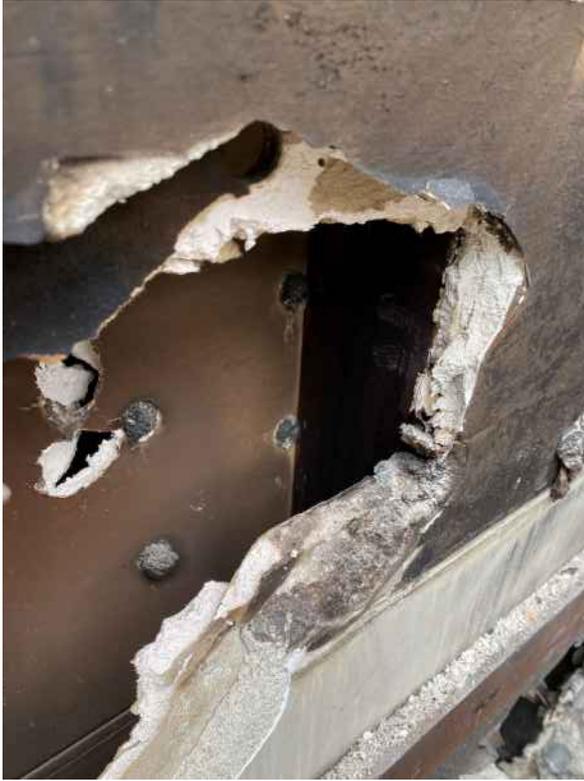
**Photo 46: Burned Interior Wall Post**

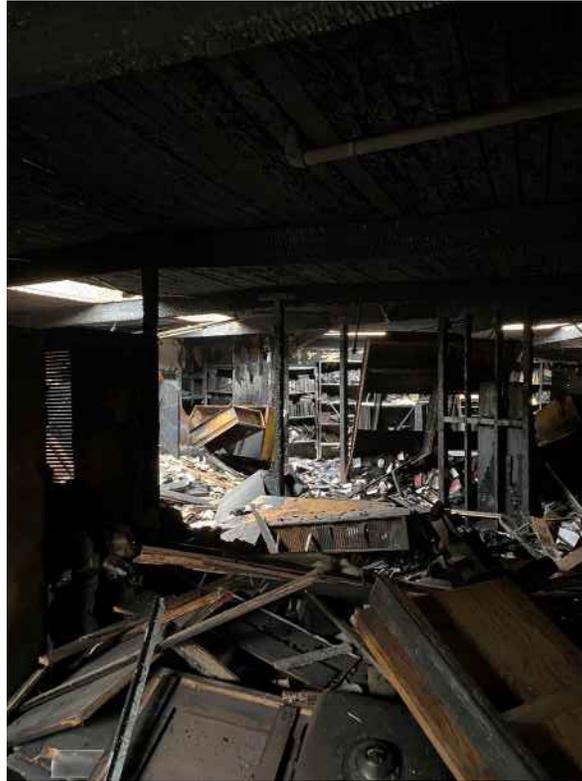
**Photo 47: View of Most-Compromised Building Section**

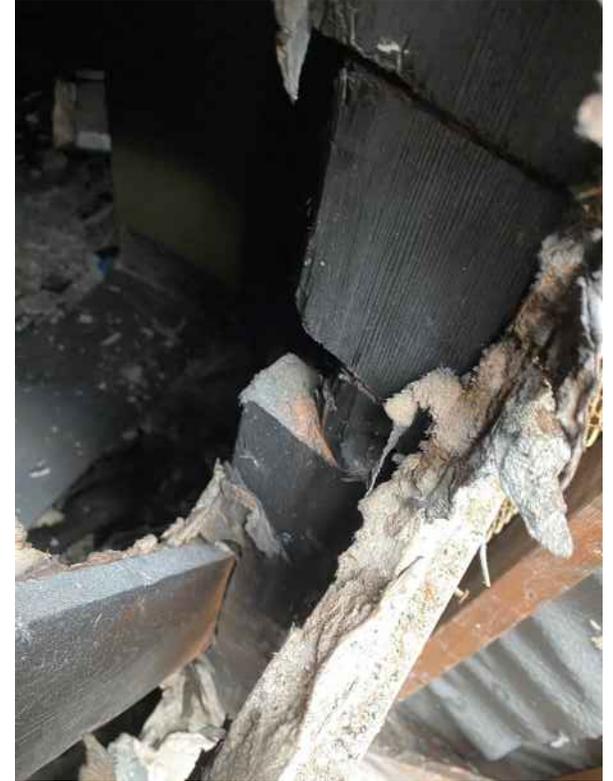
**Photo 48: Damaged Portion of Wall**
